## ***Quick resolution of ambiguities required!***

*RTK positioning of ships using Leica GPS500*

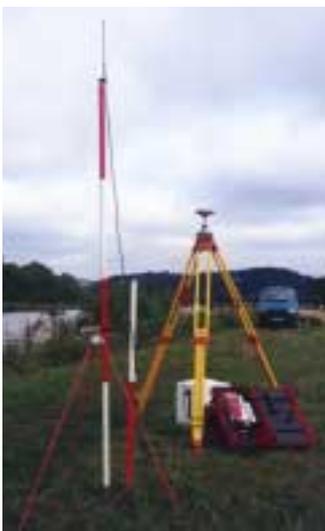
*GPS 530 at full speed*

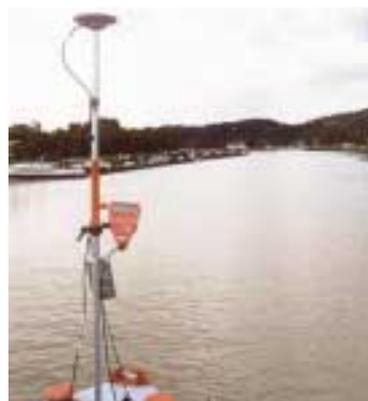
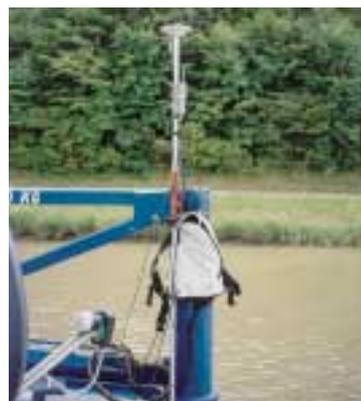
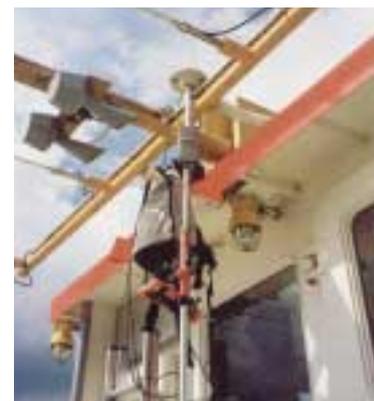
*Above: Bridge and lock buildings caused GPS shadows. However, this did not prove a hindrance to the Leica GPS500. Below: Reference station and computer base. Right: Even with all the various ships and different mountings involved, it took less than 5 minutes to fit the two Leica GPS sensors and radio transmission equipment to the bow and stern.*

During Summer 2000, a total of three SR 530 GPS receivers were used for the monitored journeys. The reference station was in the middle of the test course on an embankment over a shadow-free hectometre stone of known coordinates. The two rovers were each used with a backpack system with a plumbing pole and an AT 502 GPS antenna as well as a Leica TCPS26 radio data modem. The modem transmitted the determined 3-D positions to a base station on the bank in the test bus, which housed a computer. The received data in NMEA format was recorded on a laptop, saved and then analysed immediately after the ship had passed with the Geodetic Institute's shiPos software and LISCAD Plus from Leica Geosystems.

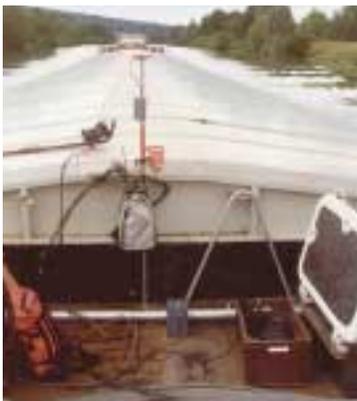
*GPS rover with TCPS26 modem*

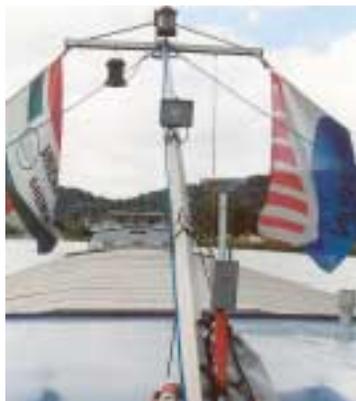
*GPS rover at the bow*
